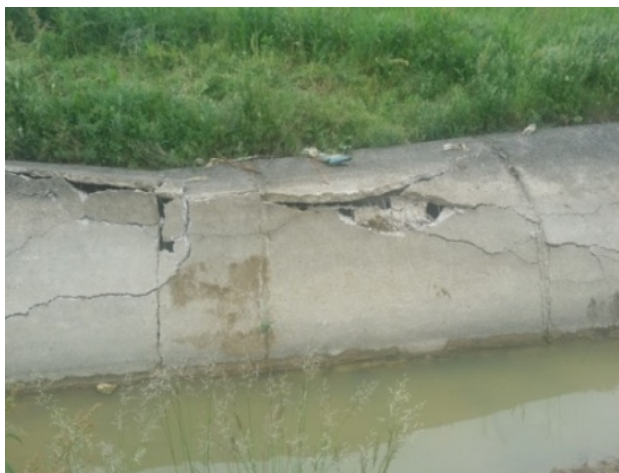
Fig. 9, Current status of a partially restored canal

Parts in the upper or lower leakage are generally in a good condition. The increased vegetation is the main concern. A gate of the discharged canal is not in function. The maintenance of the gallery is at the appropriate level and the accumulation which has increased the sedimentation, is considered a phenomenon[10].

The greatest losses are in the distributive canals. These structures are built of concrete. The length of the open canals, aqueducts, and cross-overs from the starting point of the canal, are approximately 24500m. The length of the canal with a trapeze shape is 18913.85m, where, up to this moment, 80% have been rehabilitated, of which the failure of modern material technology is easily noted, specifically in the material joints (see picture 9,10&11).

Pictures show the rehabilitation of the canals, but the failure of the joint materials can be easily seen. According to the research done, we have found out that the material used is of new technology. We have found the adequate materials for these issues, such as, Fix-O-Flex – the German manufacturer. With the introduction of this material, the biggest bulk of flows is eliminated. Other facilities are in poor conditions, where we can find Water loss and in certain parts, even the normal Water supply is in danger. Out of all the damaged buildings, the aqueducts are also included, where there is a need of the general overhaul, as soon as possible. In these objects, we can observe a huge Water loss, as a result of the degradation of materials and depreciation. Physical damages are as a result of the terminal side, from the purpose of the Water flow. These impairments have a total length of 50cm. After all of the constructive rehabilitation of the

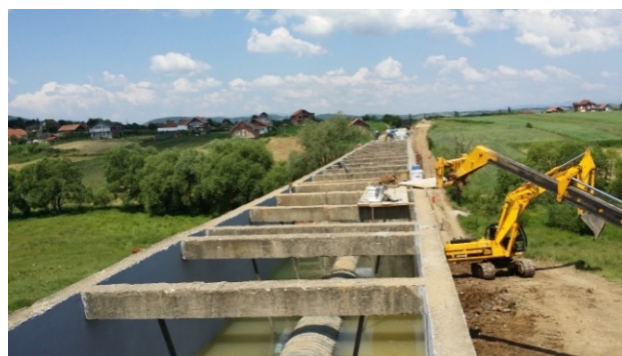
Fig.10, Current status of a partially restored canal

This level reaches the Water with low temperatures, due to freezing, the concrete structure gets damaged and, with time, it may face bigger damages with larger consequences (Foto 2&3). Due to freezing and external Water flow, the pillar holders may also get damaged. The damages are evident and, mostly, in the protective layer of armor, where we can easily notice a reinforced degradation[6].
