Tabique walls typologies and building details in the Alto Douro Wine Region

Abstract: - *Tabique* is one of the main Portuguese traditional building techniques which use raw materials as earth, wood and stone. In general, a *tabique* building component as a wall is formed by a timber structure more or less complex, filled and plastered by a composite earth based material. The earth based material has an important role in this system because it protects the internal timber structure as well as it is a finishing. The *Alto Douro Wine Region*, located in the interior of Northern Portugal, added to the UNESCO's World Heritage Sites List in December 2001 as an 'evolved continuing cultural landscape', is rich in terms of *tabique* heritage constructions. Meanwhile, previous research works have shown that the existing *tabique* constructions, in this region, present a generalized advanced stage of deterioration. This aspect associated to the fact that there is still a lack of scientific studies done in this field motivated the writing of this paper, which its main objective is to identify the diversity of structural timber *tabique* walls solutions and building details presents in the *t

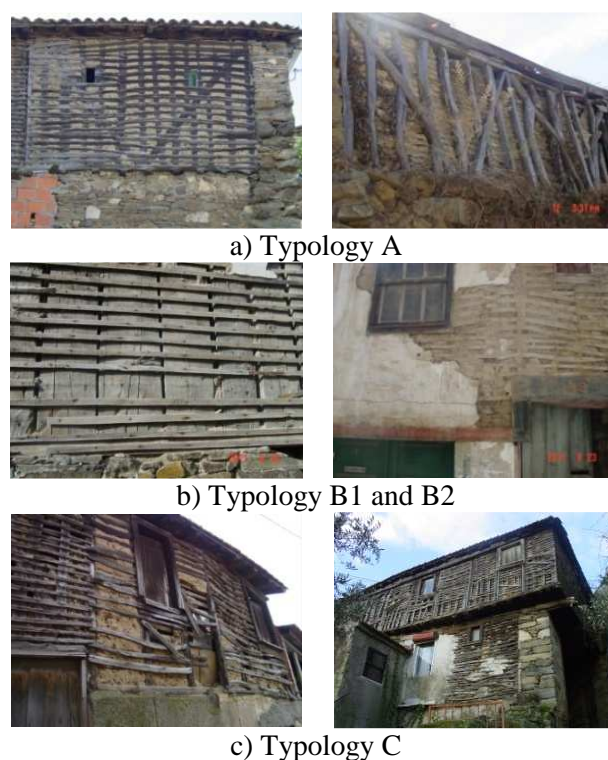
Fig. 3 – Structural timber typologies

During the mentioned fieldwork, it was observed that exterior *tabique* walls can present three main typologies. These typologies were designated typology A, B and C and are illustrated in Fig. 3.

The typology A, Fig. 3-a), is formed of vertical studs and braces (diagonally orientated, at approximately 45°, studs) while the laths, placed in the horizontal direction, are applied in both side of the studs with metal nails as connectors. The dimensions of all these elements have significant variations [4] and their appearance or their curved longitudinal axes and rounded cross section corners suggest that they were obtained by a manual cut process. A typical detail of this typology is illustrated in Fig. 4. The brace is a unique peace witch intersect and cut the vertical studs, all the

Regarding typology B, illustrated in Fig. 3-b), she was divide in two typologies B1 and B2 since the above mentioned fieldwork indicates that the vertical elements can be boards (typology B1) or studs (typology B2). Comparatively with typology A, braces are not present in these timber structural solutions. Furthermore the elements presents in typology B1 appeared to have been obtained through a mechanical cut process due to: a slight uniformity in their dimensions, a clean appearance, straight longitudinal axis and cross sections corners perfectly cut. Fig. 5 shows a typical detail of typology B1.

Finally, typology C, shown in Fig. 3-c), is characterized by a sequence of timber structural subframes separated by posts, in which the dimensions and orientation of the timber elements can vary substantially. Each subframe and corresponding components as it one properties and this framing system can be seen as a combination of typology A and B previously described. Furthermore two new components rises in this configuration, a middle rail, an horizontal element with the same dimensions of the studs which intersect and cut the vertical studs (subframe C in Fig. 7) and posts, vertical elements used to separate the subframes. Braces can also be presents in this solution. In Fig. 7 a typical detail of this typology is delivered.

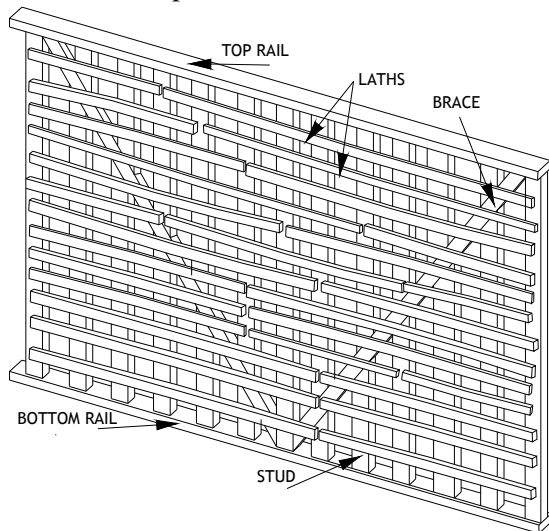
Fig. 4 – Typology A

studs are in the same plane and are connected thought nails to the bottom en top rails. We strongly believe that the diagonally orientated stud act has a bracing system component relatively to the timber structure plane and allow the *tabique* wall to withstand horizontal forces acting in the plane of the wall structure. One of them will be in tension and the other in compression.

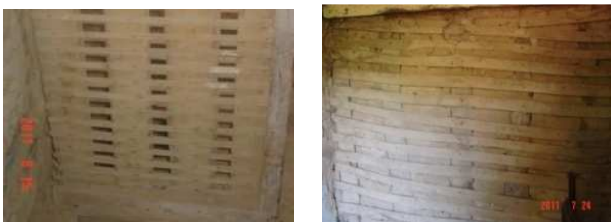
Fig. 8 – Partition walls typologies

a) Typology A b) Typology B

Typology A, Fig. 8-a), is characterized to be formed of boards for the vertical elements and laths for the horizontal ones. Those elements show approximately uniform dimensions, a clean appearance, straight longitudinal axis and well defined cross section corners, suggesting that a mechanical cut process originate them, and thus similar to typology B1 previously defined to exterior walls, Fig. 9.

In contrast the components of typology B, Fig. 8-b), have the same characteristic of typology B2 and A defined to exterior walls and thus may have also been obtained by a manual cut process; nevertheless no braces elements were founded. A typical detail of this typology is shown in Fig. 10.

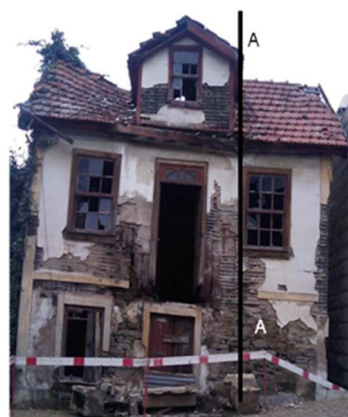
Fig. 12 - The *tabique* dwelling used as reference

As it was stated above, a *tabique* dwelling was used as a reference of a *tabique* dwelling of two floors which has exterior *tabique* walls at the first floor level, Fig. 12. This is one of the most common solutions in the *Alto Douro Wine Region*. The other common solution is a *tabique* dwelling of two floors, having exterior stone masonry walls and *tabique* partition walls. This *tabique* dwelling is located in the *Lamego* municipality, in the *Alto Douro Wine Region*. The GPS coordinates of the precise location are: latitude of N 41° 09.230' and longitude of W 7° 47.117'.

Fig. 12 illustrates the frontal view of the studied *tabique* dwelling which is over 100 years old. It is a two floors dwelling (ground and first floors), having an attic. The exterior walls at ground level are stone masonry walls while the exterior walls at the first floor and all the partition walls are *tabique* walls. From Fig. 13, a cross section along the line A-A represented in Fig. 12, it is noticed that there is partition *tabique* wall at the ground floor level, this is not a common building solution among the *tabique* buildings already studied. It is evident from Fig. 12 that this dwelling presents an advanced level of deterioration. This fact is in accordance with the results reported in previous works [6], which highlight for the urgency of conservation demand that this type of buildings are requiring.

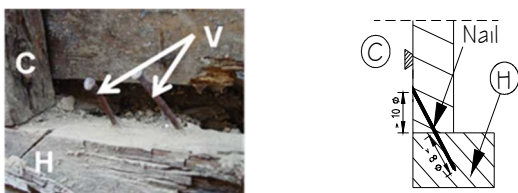
Fig. 20 - Connection between exterior *tabique* wall and the bottom rails

We are presenting in Fig. 20 a building solution detail of the connection between an exterior *tabique* wall and the masonry wall. The vertical timber elements of the exterior *tabique* wall are connected to the bottom rail (H) by metal nails (V) and according to the detail delivered in Fig. 20.

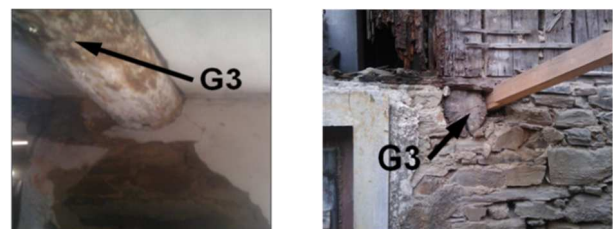
a) The beam
b) The support
Figure 23 – Principal beam and support

As it was stated above, in general, the timber floors and in particular the first floor has the following structural solution: the main or the principal beams are directly supported on the masonry walls; the floor joists are supported on the previously ones; the flooring boards are supported on the floor joists. The main timber floor beams G3 in Fig. 23-a), are simple supported directly to the top edge of the exterior masonry wall. The support length corresponds to the thickness of the wall and as Fig. 23-b) documents.

In this particular case, it corresponds to a 0.60 m average thickness. Figs. 23-b) and 24 also gives guidance to realise how the exterior *tabique* wall is supported (detail II of Fig. 13) and complements the description done related to Fig. 13. In Figs. 23-b) and 24, the main timber floor, the bottom rail and the vertical timber elements of the wall are clearly identified as well as, their disposition among them. The outer face coating of the walls have completely deteriorated and disappeared in this part of the walls and this is the reason because the main timber beam

top surface is exposed to the outside, Fig. 23-b). In normal conditions, it should be covered and protected with the earth based mortar.
