Structural and Material Characterization of a Haussmann Building Complex at *La Madeleine*, Paris. The First Step Before Sustainable Rehabilitation and Strengthening

Key-Words: - Traditional buildings, Haussmann buildings; rehabilitation; structural characterization; strengthening; sustainability.

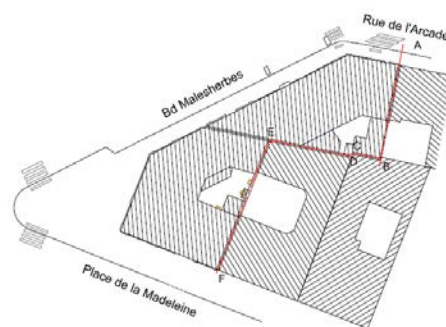
Fig. 1 – Complex implantation

Figure 1 shows the complex implantation and Fig. 2 shows a front view of the existing facade.

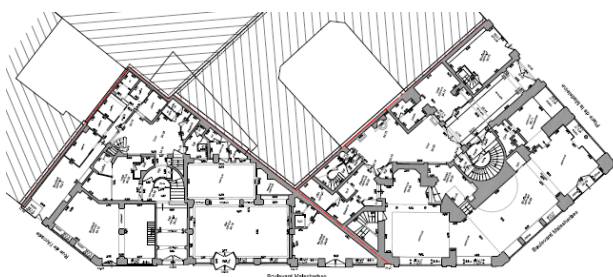
The building complex is constituted by two Haussmann buildings, built between 1830 and 1841. Malesherbes building on the left and Madeleine building on the right in Fig. 1-a). Malesherbes building as a gross floor area of 365 m² and 7 stories and Madeleine building as a gross floor area 416 m² and 6 stories. The ground floor, Fig.3, of the two buildings has a commercial use and the basement is used as a storage and to the technical equipment.

Fig. 4 – Ground floor

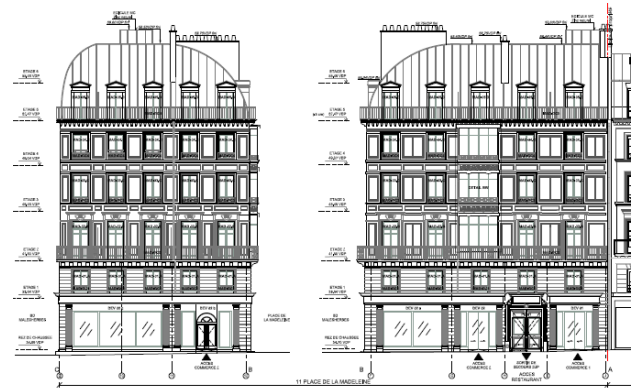
The other are office floors. The main Haussmann facades are made of dressed stone, excepted the two upper floors which are made with a timber frame

solution. The facades located in the backside are made with a timber frame or steel frame solution. Fig. 4 shows Madeleine building facade viewed from *Place Madeleine*, this is a typical Haussmann facade.

Fig. 4 - Madeleine building facade

The facades existing prior to the advent of Haussmann buildings were made of timber frame structure with limestone rubble, [2]. The Haussmann facades, Fig. 3, are made with a 55 cm width dressed stones supported by the limestone walls located beneath them, on the basement floor. The last storey of Madeleine facade, under the ceiling, is made of a timber frame structure, as the two uppers stories of Malesherbes. For both facades, the last storey is made of a curved timber frame structure. The backside facades are, from the bottom to the top made of a timber frame structure full with limestone rubble or a metallic frame structure full with bricks.

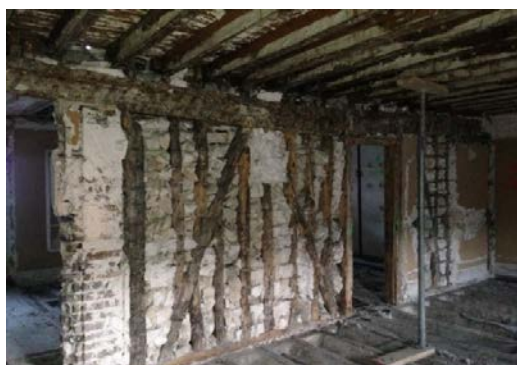
Along the Haussmann building complex, there is an interior timber frame wall going parallel to the main facades and approximately located at the middle distance between the front and the backside facade. This interior timber frame wall supports the floors. The other solution present in this building complex consists of a clay brick walls. The timber frame structure is made of oak tree with an infill, of clay bricks, Fig. 6.

Fig. 6 - Clay bricks infill

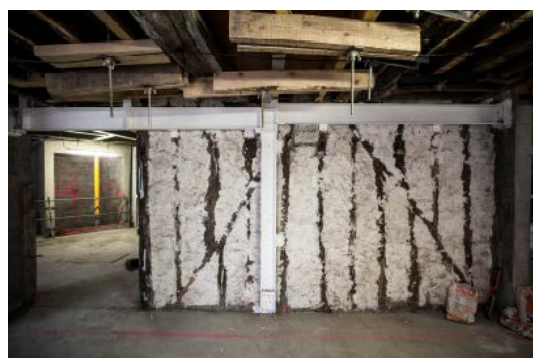
Another solution is the use of limestone rubble for the infill, Fig. 7. At the ground floor level, the timber frame wall is interrupted and supported by masonry columns.

Fig. 7 - Limestone rubble infill

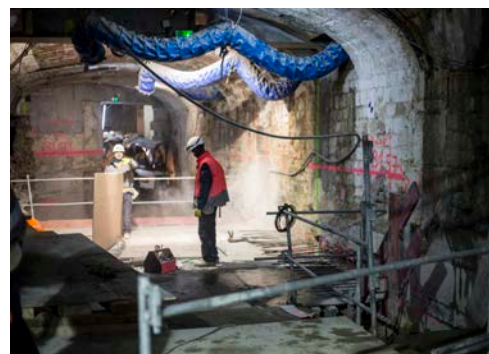
This building complex has one basement floor. This floor is realized with limestone masonry vaults, Fig.12. The vaults are supported by interior and exterior limestone rubble masonry walls. The interior walls have a thickness varying from 40 cm to 65 cm and the exterior walls have a thickness equal to 80 cm. This was the main structural system since concrete was not yet used and because timber elements could not be used in the basement which has high humidity levels.

Fig. 12 – Basement walls

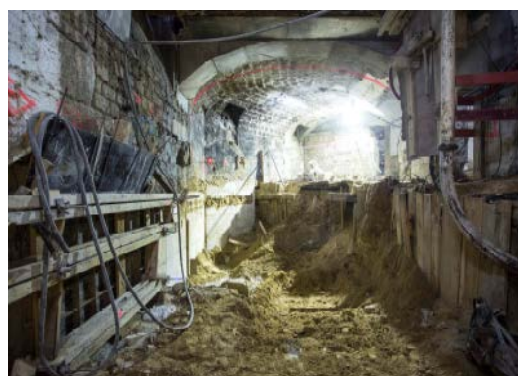
The vaults observed in this Haussmann complex are masonry barrel vaults. A survey was performed to obtain the vaults dimensions, Fig.13, and three parameters were considered, the distance between the vault footer and the keystone which define the rise and the free span and the rise to span ratio.

Fig. 13 – Basement vault

From table 4 it is possible to conclude that the rise to span ratio varies from 0.15 to 0.39. According to [11] the critical rise-to-span ratio is equal to 0.2 since the shallower the vault, the greater is the horizontal reaction, as already perceived at least in the 1st century BCE, and reported by Vitruvius within De Architectura, [12], [13], [14].

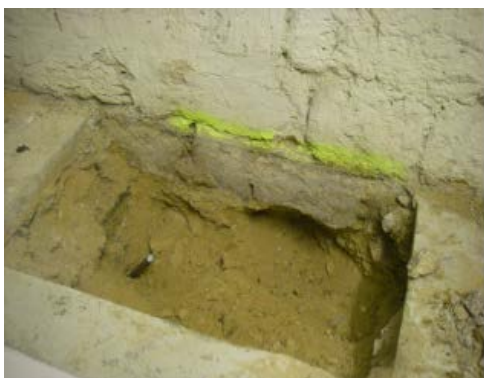
In order to identify the foundations, a survey was realized in three foundation points of investigations. The foundations were manually dug with a shovel, to a depth between 0,40 and 1,20 meters. The results clearly indicated that the foundations of the building complexes are usually obtained by extending the limestone rubble masonry walls below the ground, Fig. 14 and Fig. 15.

Fig. 14 – Wall fondation

The depth of those foundations walls varies between 15 cm and 1 meter.

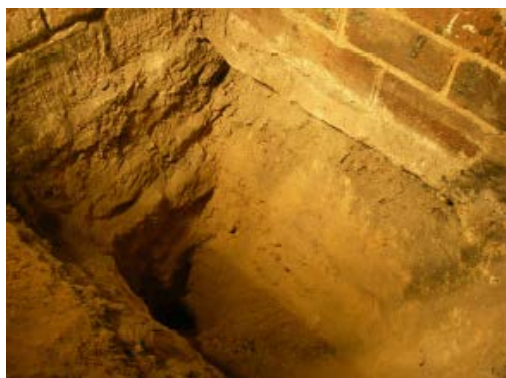
Fig. 15 – Foundation by wall extension

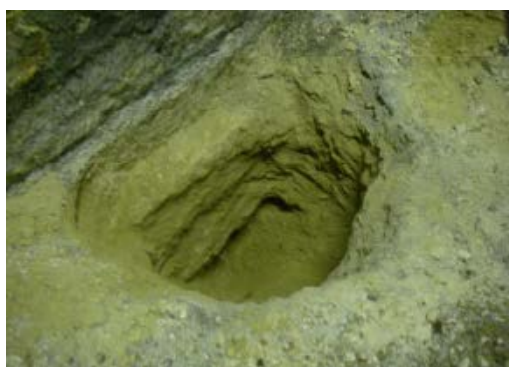
Besides, some walls have limestone masonry or concrete strip footings to support them, Fig. 16 and Fig. 17.

Fig. 16 – Limestone masonry strip footing

In those cases, the footings have a height varying between 3 cm and 40 cm, Fig. 16 and Fig. 17 and the width extending beyond the walls internal surface varies between 4 and 13 cm.

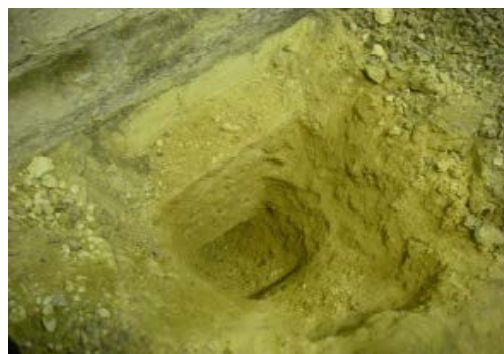
Fig. 17 – Limestone masonry strip footing
